KNIGHT VISION HOME INSPECTIONS PLLC

PROFESSIONAL TEXAS INSPECTORS MASTER REPORT 1.0

1234 Main Street San Antonio TX 78253

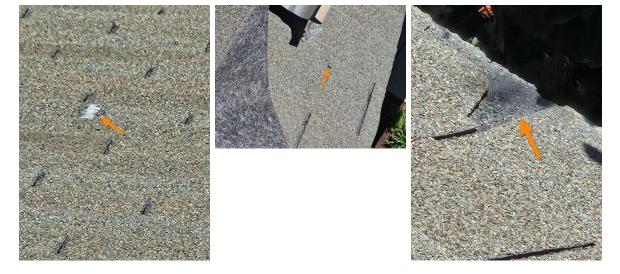
2: Roof Coverings Damaged

Roof coverings exhibited general damage that could affect performance. Recommend a qualified roofer evaluate and repair.

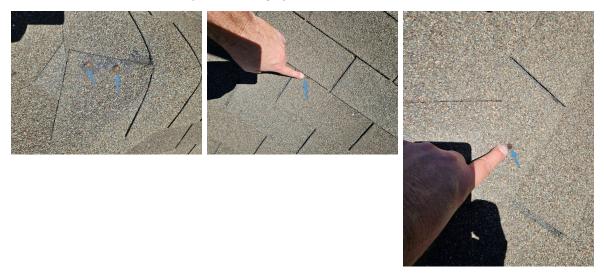
3: Exposed Nails

Under-driven or exposed nails were found in one or more areas of the roof coverings. Recommend sealing nail heads periodically to prevent potential leaks in the future.

Recommendation: Contact a handyman or DIY project

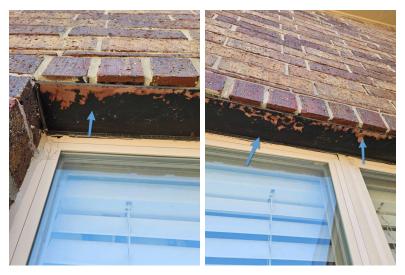
Lentils over doors and windows should be painted periodically to help keep them protected from moisture so that they don't expand as easily and crack brick in the future.

Recommendation: Contact a handyman or DIY project

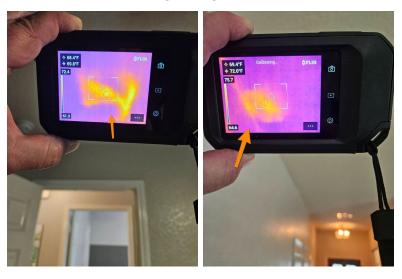
Few areas in the ceiling had thermal anomalies. This is more then likely due to the insulation in the attic disturbed

Recommendation: Contact a qualified professional.

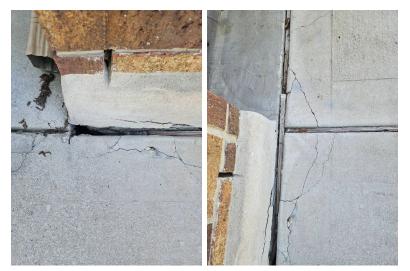
Cracks or damage was noted in the sidewalk/driveway at the time of inspection.

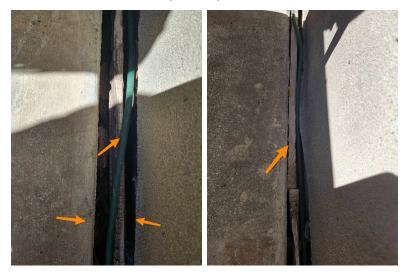
2: Condenser cement pad pulling away from house

Observed the cement pad has a larger the normal gap from the house. This is from settlement. Also has the wood boards in place. I would recommend removing the wood boards to not attract wood destroying insects, and sealing the gap. The more water that gets behind it will cause erosion under the pad

Recommendation: Contact a qualified professional.

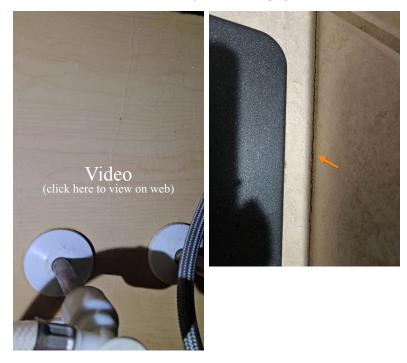
The caulking around the kitchen sink(s) is/are in need of repair, it has active water dripping down inside the cabinet.

Recommendation: Contact a handyman or DIY project

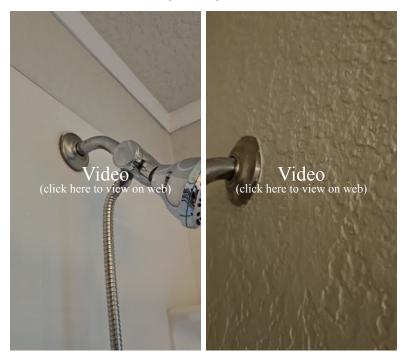
The faucet(s) and/or faucet valve(s) were not sealed to the wall. This can allow for water infiltration behind the wall creating damage. Proper sealing of any and all faucets is recommended by a qualified person.

Recommendation: Contact a qualified professional.

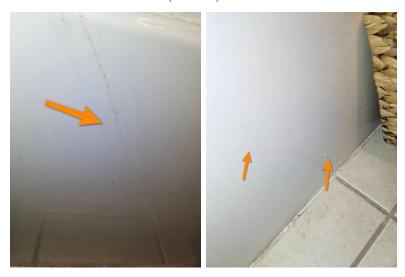
Observed a Crack on the outside of the bathtub in the master bathroom that has had caulking over it. Doesn't seem to be leaking today. Possible replacement might be needed

Recommendation: Contact a qualified professional.

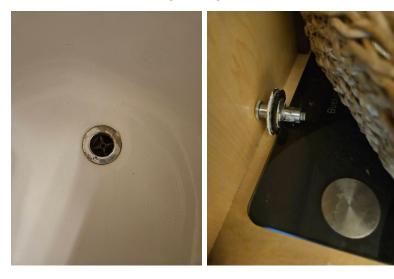
2: Drain stop not installed

Maintenance Recommendations, Items to Monitor, Further Evaluation Recommended
Hallway bathroom is missing the drain stop to the bathtub. I found it under the sink. Should be Installed

Recommendation: Contact a qualified professional.
